AFCEC-CX-TY-TP-2013-0006

## **EXPERIMENTAL INVESTIGATION OF WIDESPREAD DELAMINATION DAMAGE TO COMPOSITE MATERIALS CAUSED BY RADIANT HEATING**

June 2013

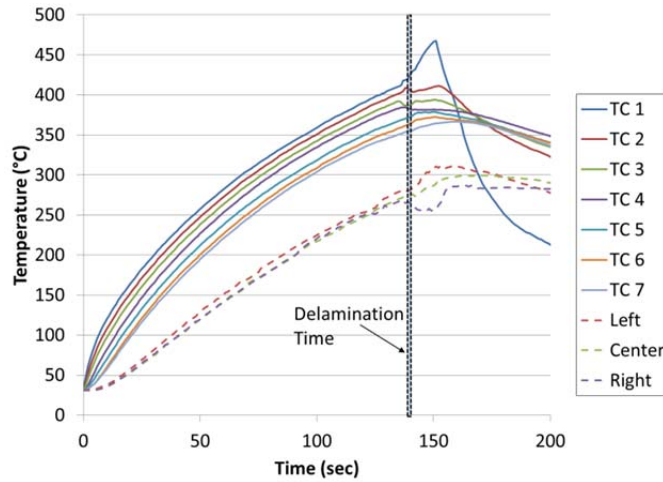
Figure 11. Temperature history data from embedded and backface TCs.

The approximate delamination time was estimated from the embedded TC and backface TC readings, as shown in Figure 11. These times corresponded well with the time of global plate buckling observed during testing. Deviations in the measured embedded TC temperatures are seen during delamination as plies separate from one another. If the TC remains bonded to the ply on the heat-exposed side of the plate, for example, a short-term increase in the rate of temperature increase is seen. A short-term reduction in the rate of temperature increase, and sometimes a temperature drop, is seen if the TC remains bonded to the ply away from the heating. Deviations in the backface TC temperatures, which are originally in contact with the insulated side of the plate, are seen when the surface of the plate is moved away from the TC, such as when global buckling occurs.

Two criteria were used to determine the time of global plate delamination. The first criterion was the time when three of the embedded TCs showed deviations in the temperature loading rate. Indication from a single TC was not considered definitive because it could indicate when a small crack occurred around an individual TC and not be a good indicator of plate-wide delamination. The second criterion used was when all three backface TC readings (left, center and right) showed a deviation, as discussed above. The time and temperatures reported here are the averages of these two methods.

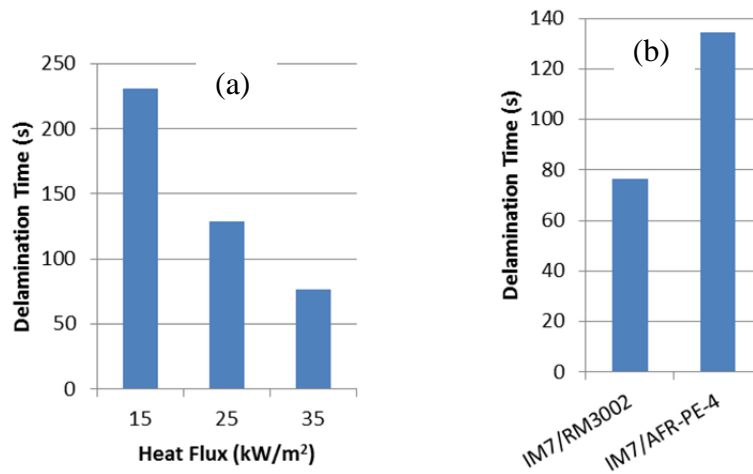
Figure 12. Delamination times in (a) dry IM7/RM3002 plates at three heat flux magnitudes and (b) in dry plates tested at 35 kW/m².

Delamination times for plates tested dry are shown in Figure 12 as a function of heat flux for IM7/RM3002 in Figure 12(a) and comparing IM7/RM3002 to IM7/AFR-PE-4 in Figure 12(b). Results from these two materials can be compared because the plates had nominally the same thickness. As would be expected, the time to delamination decreases rapidly with increasing heat flux as shown in Figure 12(a). Limited testing was performed on IM7/977-3 and IM7/AFR-PE-4 composites at a single heat flux intensity, so the variation with heat flux is unknown. Comparison between materials in Figure 12(b) shows that material having the higher dry  $T_g$ , IM7/AFR-PE-4, took longer to delaminate.

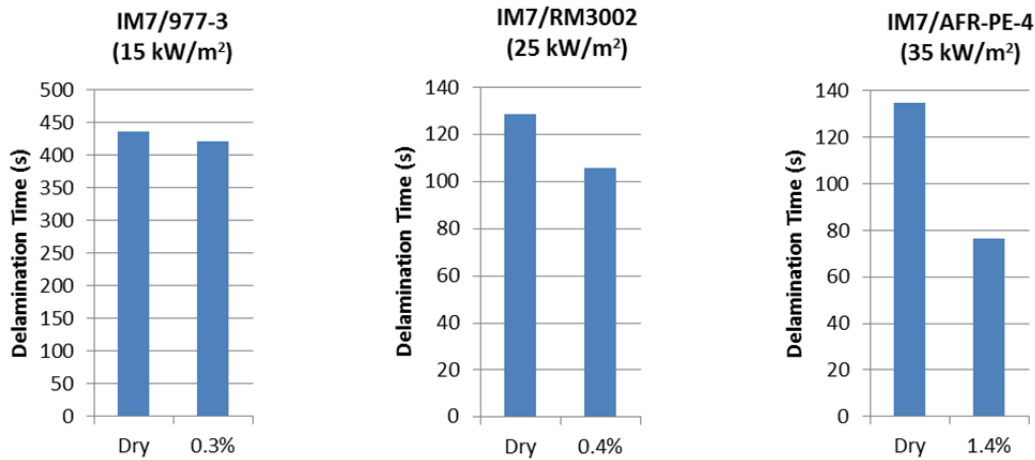
Figure 13. Effect of moisture content on the time to delamination at fixed heat flux magnitudes.

When moisture was added to the plates IM7/AFR-PE-4 had the greatest reduction in the time to delamination, as shown in Figure 13. Note that it also had the highest moisture content. The time to delamination at 35 kW/m<sup>2</sup> was actually reduced to the same time (77 s) as the lower T<sub>g</sub> material, IM7/RM3002, tested dry at this heat flux. No conclusion can be made about the relative sensitivity to moisture for all materials tested since each was at a different moisture content at the time of testing. The lowest T<sub>g</sub> material, IM7/977-3, showed the least reduction in time to delamination tested wet and dry. It is not clear from the limited data what effect the greater specimen thickness, lower heat flux, and smaller temperature gradient had on these samples with regard to the elevated moisture content. Additional testing is needed to examine all of these effects.

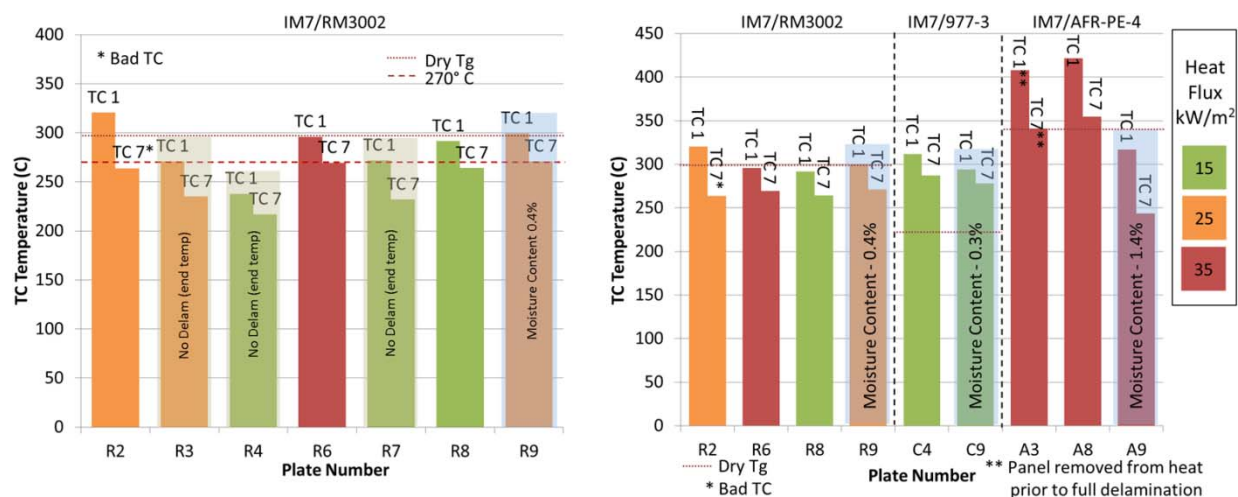
Figure 14. Front (TC 1) and back (TC 7) temperatures at the time of delamination.

Direct comparisons of the three different composite materials cannot be made because of differences in material thickness and in the heat flux intensities to which each material was exposed. However, the plate temperatures at which delamination occurred can be compared, as shown in Figure 14 for all three materials. Ply temperatures on front (exposed to heat) and back (insulated) of the laminate plate (TC 1 and 7) were recorded at the time of apparent delamination. Results for IM7/RM3002 in Figure 14 also show the temperatures at the time a plate was removed from heat for plates that did not delaminate. Since IM7/RM3002 was tested at three heat flux intensities, some observation can be made regarding the temperature at which delamination occurred independent of the heat flux applied. Delamination did not occur until the TC 7 temperatures reached approximately 270 °C for all IM7/RM3002 plates tested. Plates that did not reach this temperature at any ply in the samples did not delaminate.

The material with the highest T<sub>g</sub>, IM7/AFR-PE-4, showed the largest reduction in the temperature at which delamination occurs due to the presence of moisture. As shown in Figure 14, temperatures varied between 341 °C on the back faces and 422 °C on the front faces of the dry material at the time of delamination. When delamination occurred, the entire plate was above the dry T<sub>g</sub> for this material, cited by the manufacturer as 340 °C. Water in general acts as a plasticizer, lowering the T<sub>g</sub>, but its effect on this condensation polyimide resin is not known. The temperatures in the plate with 1.4-percent moisture content varied from 244 °C to 317 °C at the time of delamination, well below the dry T<sub>g</sub>.

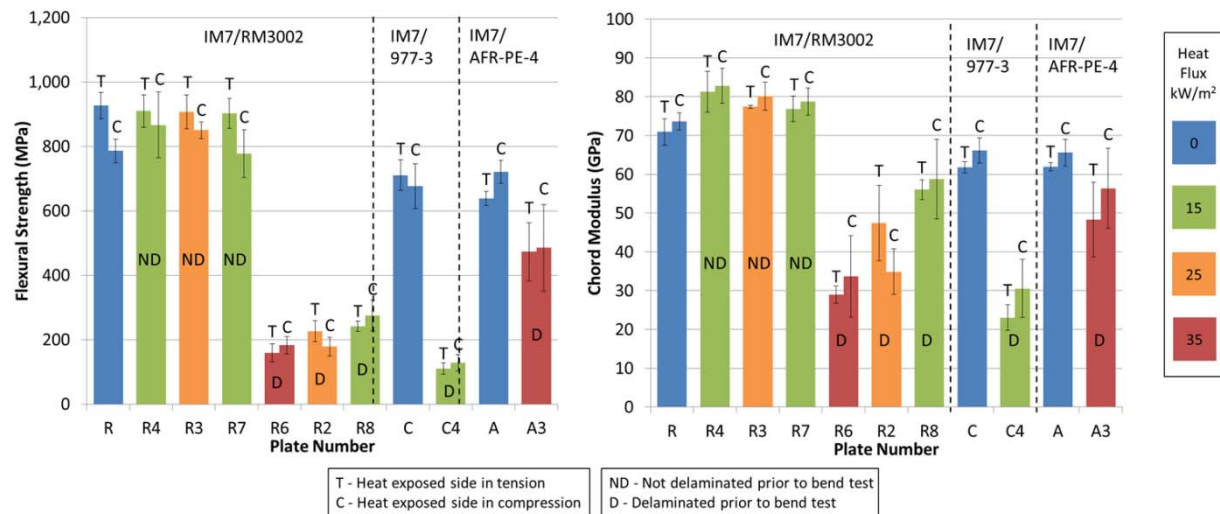
Figure 15. Average flexural strength and chord modulus at varied degrees of heat exposure.

Four-point bend testing was performed on unexposed and heat-exposed samples with the heat-exposed side in both compression and tension. The flexural strength and chord modulus are shown in Figure 15. The standard deviation of typically four tests with the heat exposed side in tension (T) and five in compression (C) are shown with the error bars in the figures. Note that plates that did not delaminate from heat exposure are marked with 'ND' and those that did with 'D'.

The IM7/977-3 and IM7/AFR-PE-4 materials also had a large drop in flexural strength once delamination occurred. The highest  $T_g$  material, IM7/AFR-PE-4, demonstrated the smallest drop in strength with delamination in the one plate tested (approximately 30 percent). It is important to note, however, that plate A3 was removed from heat just as delamination started. So it is not clear if reduction in flexural strength is less severe in this material or if similar reductions would be seen if allowed to complete delamination.

The overall effect on material chord modulus is similar to that for the strength. Here, the effect on modulus was a decrease of 23 percent at the lowest heat flux and a decrease of 60 percent at the highest heat flux. The apparent increase in modulus of the IM7/RM3002 plates without delamination (cf. plates R, R3, R4, and R7 in Figure 15) is likely due to plate-to-plate variation or post-curing.

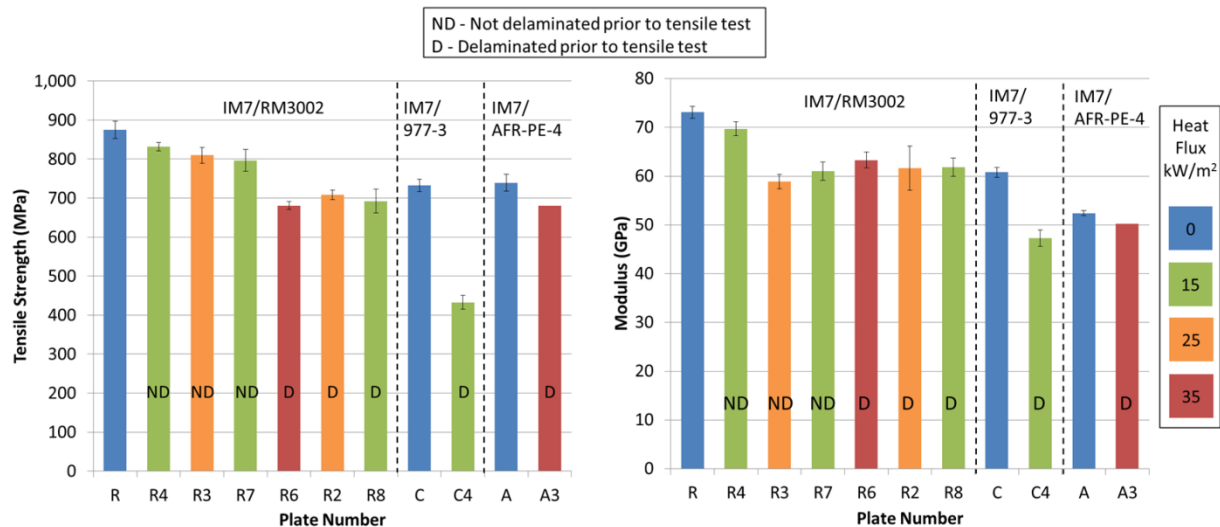
Figure 16. Average tensile strength and modulus at varied degrees of heat exposure.

Tensile testing was performed on unexposed and heat-exposed samples. The tensile strength and tensile chord modulus of elasticity are shown in Figure 16. The standard deviation of six samples are shown with the error bars in the figures. Only three samples were tested for plates A, C, C4, R and R6. Data for A3 is from a single sample so no standard deviation is shown. In general, the heat-exposed plates that delaminated showed less degradation in the tensile properties than the flexural properties, as would be expected by the dominant damage mode of delamination.

All materials showed a reduction in tensile strength for samples with delaminations from heat exposure. This reduction was only large for IM7/977-3, which had a 40-percent drop in tensile strength between the two plates tested. Tensile modulus was also reduced for this material. IM7/AFR-PE-4 showed a similar trend, but the magnitude of the reduction in properties was much smaller. The material IM7/RM3002, with the largest number of exposures, showed some mixed results.

The tensile strength of IM7/RM3002 samples with delaminations from heat exposure was lower than samples with no delaminations, even with heat exposure. This is consistent with the other materials. The chord modulus is also lower for samples with delaminations than material with no heat exposure (plate R). However, plates R3 and R7 with no delaminations also have a lower chord modulus similar to the delaminated plates. Plate variation may be responsible for the differences in chord modulus rather than the effect of delamination. Future testing should ensure tight control on consistency between plates to avoid this uncertainty.
